Subject: Braidwood Station, Unit 2, 60-Day Response to First Revised NRC Order
EA-03-009, "Issuance of First Revised NRC Order (EA-03-009) Establishing Interim
Inspection Requirements for Reactor Pressure Vessel Heads at Pressurized Water
Reactors"

A2R11 Reactor Vessel Head Visual Inspection Results

**"Braidwood Unit 2 – A2R11
Reactor Vessel Head Penetration Examination
April 2005"**

Braidwood Unit 2 – A2R11 Reactor Vessel Head Penetration Examination

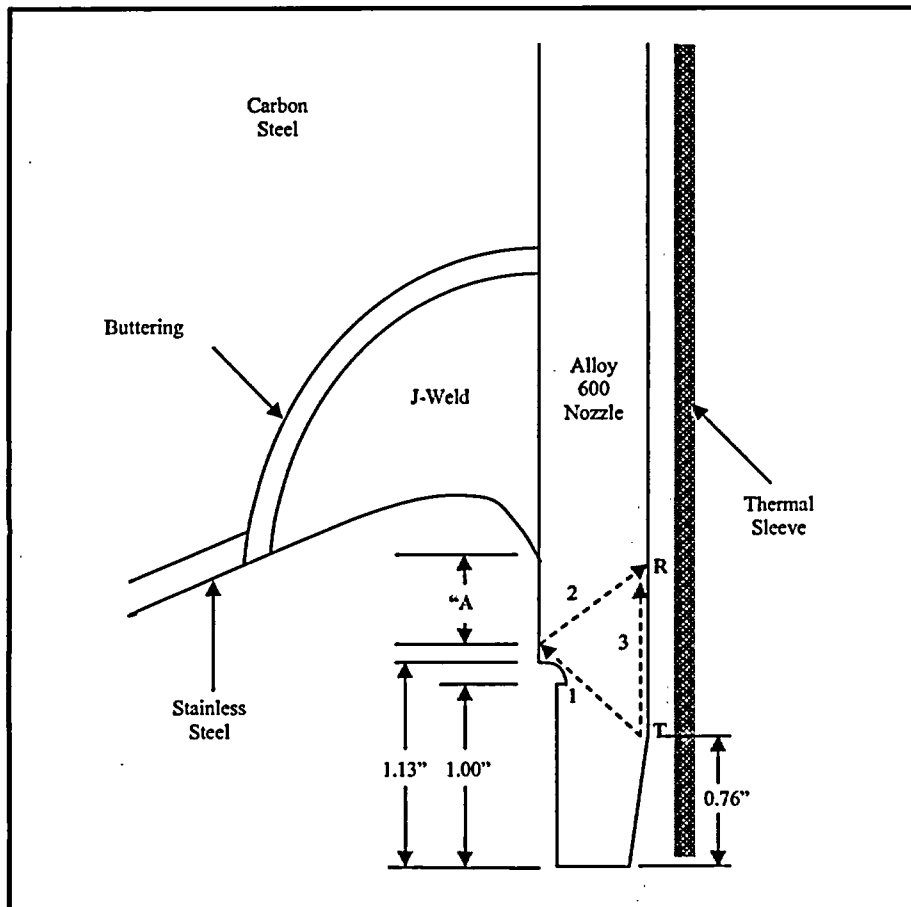
Figure 4-1: Illustration of Axially Oriented TOFD Examination Coverage on Braidwood Unit 2 Penetration Geometry at 0° (Downhill Side)

The configuration of a sleeved Braidwood CRDM penetration tube is illustrated in Figure 4-1. This figure represents the tube-to-head geometry at the penetration 0° azimuth, or "downhill" side of the tube. The bottom ends of all penetration tubes are threaded on the OD surface and have a chamfer on the ID surface. The threads extend from the bottom of the tube to an elevation of approximately 1.00" where a thread relief is machined. The top of the thread relief is 1.13" above the bottom of the tube. The distance from the top of the thread relief to the bottom of the fillet of the J-groove weld, identified as "A", varies based on location of the penetration in the head. These distances are generally longer for penetrations at "inboard" locations and become progressively shorter for penetrations located further away from the center of the head. The ID surface chamfers are machined at a 20° angle from the bottom of the tube to an elevation of 0.76".

Examination coverage on the ID surfaces of the fifty-five penetration tubes examined with Trinity Probes and twenty-three penetration tubes examined with the Open Housing Scanner extended from the top of the chamfer in each tube to at least 2.0" above the uppermost elevation of the weld. The extent of coverage was verified for each penetration by 1) confirmation that tube entry signals at the elevation of the chamfer were evident in the eddy current and ultrasonic data, and 2) direct measurements from the TOFD UT C-scans which demonstrated scan coverage elevations were in excess of 2.0" above the uppermost elevation of each weld.
